NUMBER: 23-001-07

Modular Hard Top Freedom Panel Waterleaks

2007 (JK) Wrangler/Wrangler Unlimited

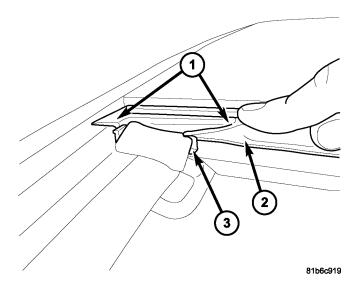
Fig. 1 FREEDOM PANEL CENTER SEAL

- 1. Remove left Freedom Panel.
- 2. Inspect the center seal that is attached to the right Freedom Panel. Look for water traces at the front molded detail area. Water collecting along the inboard edge of the panel could travel forward from the rear of the panel. If the seal, p/n 55397095AD, is cut/torn/or otherwise damaged, replacement is required.
- 3. Lift up the outboard lip on the right Freedom Panel center seal near the front molded detail. Examine area for water entry under adhesive tape and/or butyl that is applied alongside of the tape, (Fig. 1). Note any areas for repair.

- 1 CENTER SEAL FRONT MOLDED DETAIL
- 2 ADHESIVE TAPE RUNS ENTIRE LENGTH OF SEAL
- 3 BUTYL
- 4. Perform similar examination on the rear molded detail area, looking for water traces near the adhesive tape and/or butyl.
- 5. If leaks to the interior were at the dial fasteners or the B-pillar area, and no water traces are found on the right Freedom Panel inboard edge or molded detail areas of the seal, look for water traces on the hardtop panel front flange directly below the Freedom Panels. Water collected here can indicate a leak under the Freedom Panel in the "cup" area of the hard top seal, (Fig. 2). This type of leak could be a leak path under the hard top seal center mold, or a path past the foam under the right Freedom Panel rear molded detail.

- 7. IF center seal replacement is required, remove old seal and clean seal mounting surfaces of residual adhesive tape. Apply repair butyl, p/n 68027813AA, to the front and rear ends of the seal mounting zone. Remove tape liner from new seal. Locate seal at each end onto panel, pressurize each end. Proceed to pressurize center section, ensuring good, continuous adhesion.

- 8. If seal replacement is not required, add small amounts of repair butyl, p/n 68027813AA, to any areas of water entry found along the center seal of the Freedom Panel. Replace the foam on the front detail or the foam under the rear detail if it is damaged or missing with replacement closed cell foam in kit, p/n 68026937AA. (Fig. 3)

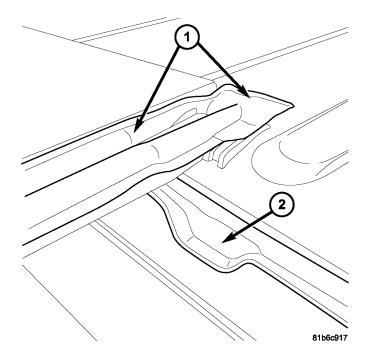
Fig. 2 HARD TOP SEAL CUP AREA

- 1 CENTER SEAL REAR MOLDED DETAIL
- 2 HARD TOP SEAL CUP AREA
- 6. Remove right Freedom Panel & set on work table, protecting edges & top surface from damage. Proceed with repairing the seal area on the right Freedom Panel.

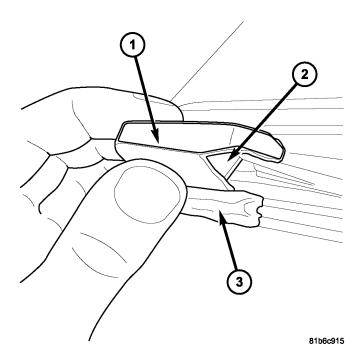
Fig. 3 FOAM AND BUTYL LOCATION

- 1 EDGE OF FOAM MUST NOT EXTEND PAST TIP OF "D" SECTION ON SEAL
- 2 "D" SECTION
- 3 BUTYL MUST BE PRESENT TO BLOCK WATER PATH BELOW "D" SECTION
- 9. If the leak path is under the hard top seal center mold, repair with butyl, p/n 68027813AA, sealer.
- 10. Replace the Freedom Panels on the vehicle, right side first, followed by the left side. Proceed to position and clamp them in the correct sequence according to the owner's manual. When installing the Freedom Panels always close the windshield latch first.
- 11. Retest to verify that the leak corrected.

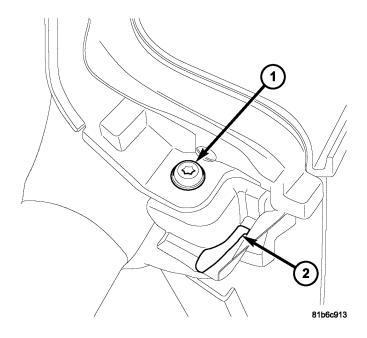
Fig. 4 B-PILLAR CUP (4 DOOR SHOWN)

- 1. Remove Left & Right Freedom Panels.
- 2. Inspect end details of hard top end seal for water traces to determine leak path. Seals that have the "cup" distorted or rolled will create a leak path. Refit the seal to correct a distorted/rolled seal.
- 3. Water traces on the hard top corner and leading into the "cup" of the upper B-pillar molded detail (4 DR), (Fig. 4), near the fastener indicate a leak either under the hard top seal or between the hard top seal and the Freedom Panel.

- 1 4 DOOR ONLY
- 2 B-PILLAR CUP SEAL
- 4. If the water trace is under the hard top end seal leading into the "cup" of the upper B-pillar molded detail, dry off the area & apply butyl, p/n 68027813AA, to close off the path under the seal to the hard top.
- 5. If the water trace is over the top of the hard top seal at the outboard corners, examine the rear outboard corners of Freedom Panel for damaged or missing foam, (Fig. 5). Replace if required with foam in kit p/n 68026937AA.

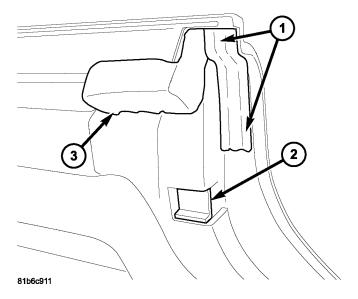
Fig. 5 REAR CORNER FOAM OF FREEDOM PANEL

- 1 HORIZONTAL SURFACE FOAM
- 2 LOCATOR NOTCH
- 3 PANEL TO B-PILLAR INTERFACE FOAM
- 6. If there is no leak under the hard top seal, no water trace at the outboard corners, and there is a water trace on hard top seal approximately 1 in. 8 in. inboard of the corners, then inspect the hard top seal for distortion or flatness. There is an insert/stuffer inside the seal end that is 7 in. 8.75 in. long. Verify that the insert is present and located all the way outboard to the hard top seal end. Shift insert outboard to support the hard top seal end if required.

- 7. If hard top seal is damaged, replace it using appropriate 2 door seal, p/n 55397058AD, or 4 door seal(s) p/n's 55397046AD and/or 55395708AC and/or 55395709AC.

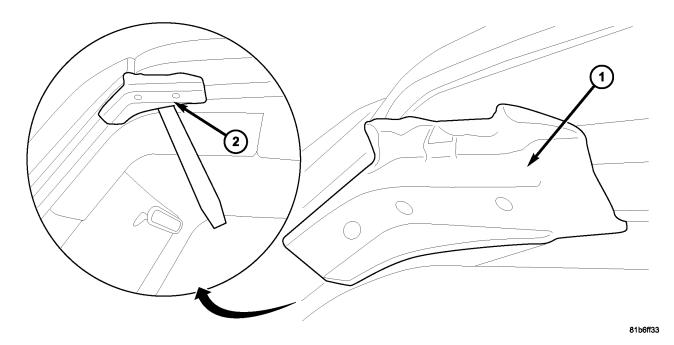
Fig. 6 HEADER SEAL TO FREEDOM PANEL TRANSITION

- 1. Water traces/drips onto the door trim panel near the handle indicate a door to body leak path.
- 2. Examine the door fit to body for an over-flush condition. Refit if over-flush greater than 1.5mm.
- 3. Examine the windshield header seal end detail to Freedom Panel for a smooth transition from the seal to the panel. A distorted/rolled seal or step off transition can lead to a leak. Refit the seal and/or bend the metal flange of the windshield frame that is to achieve a flush fit.

- 1 EXCESSIVE STEP OFF
- 2 BEND FLANGE TO OBTAIN SMOOTH TRANSITION
- 4. If water traces are on the end of the IP, the leak path is located between the windshield header and/or the windshield header seal and the Freedom Panel corner.
- 5. Remove left & right Freedom Panels.
- 6. Inspect end details of windshield header seal for water traces in the rear ward "cup" portion.
- 7. Water traces on the windshield header seal end detail rearward "cup" indicate a leak path from either the area between the Freedom Panel front corner or the windshield header seal.
- 8. Examine the front outboard corners of Freedom Panel for damaged or missing foam, (Fig. 7). Replace if required with foam in kit p/n 68026937AA.

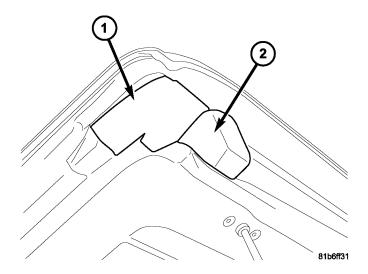
Fig. 7 FRONT CORNER OF FREEDOM PANEL

- 1 PANEL TO WINDSHIELD FOAM
- 2 PANEL TO A-PILLAR FOAM
- 9. If no issues with the Freedom Panel corner, examine the windshield header seal end details to ensure it is sealed to the windshield frame. Carefully peel back the front lip of the seal and inspect for gaps in the adhesive tape and butyl that is located under the sealing lip across the windshield header. Repair with butyl, p/n 68027813AA, as required.
- 10. Replace the windshield header seal if damaged, p/n 55395240AC and 2 p/n 06036678AA rivets.
- 11. Replace the Freedom Panels on the vehicle, right side first, followed by the left side. Proceed to position and clamp them in the correct sequence according to the owner's manual. When installing the Freedom Panels always close the windshield latch first.
- 12. Retest to verify that the leak corrected.
